# UNDERWATER BRIDGE INSPECTION REPORT

STRUCTURE NO. 84508  
CSAH NO. 30  
OVER THE  
RED RIVER OF THE NORTH  
DISTRICT 4 - WILKIN COUNTY

PREPARED FOR THE  
MINNESOTA DEPARTMENT OF TRANSPORTATION  
BY  
COLLINS ENGINEERS, INC.  
JOB NO. 5221 (CEI 55)

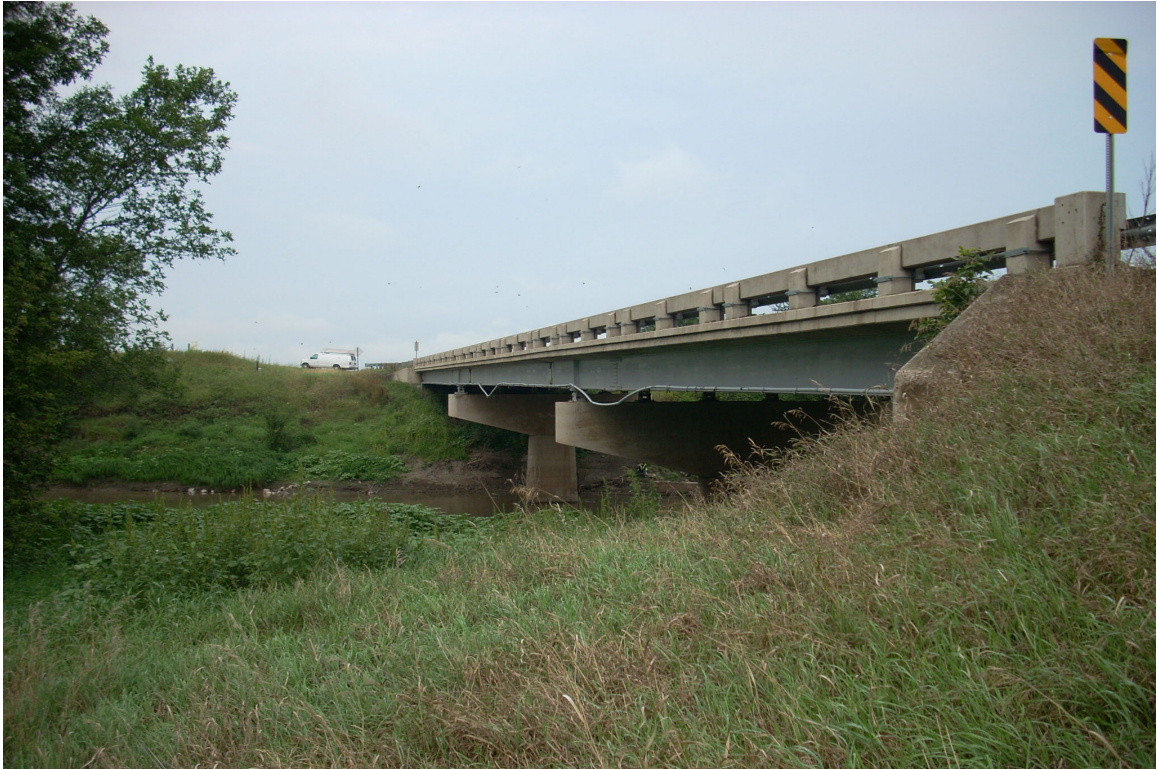
Photograph 1. Overall View of the Structure, Looking Northwest.

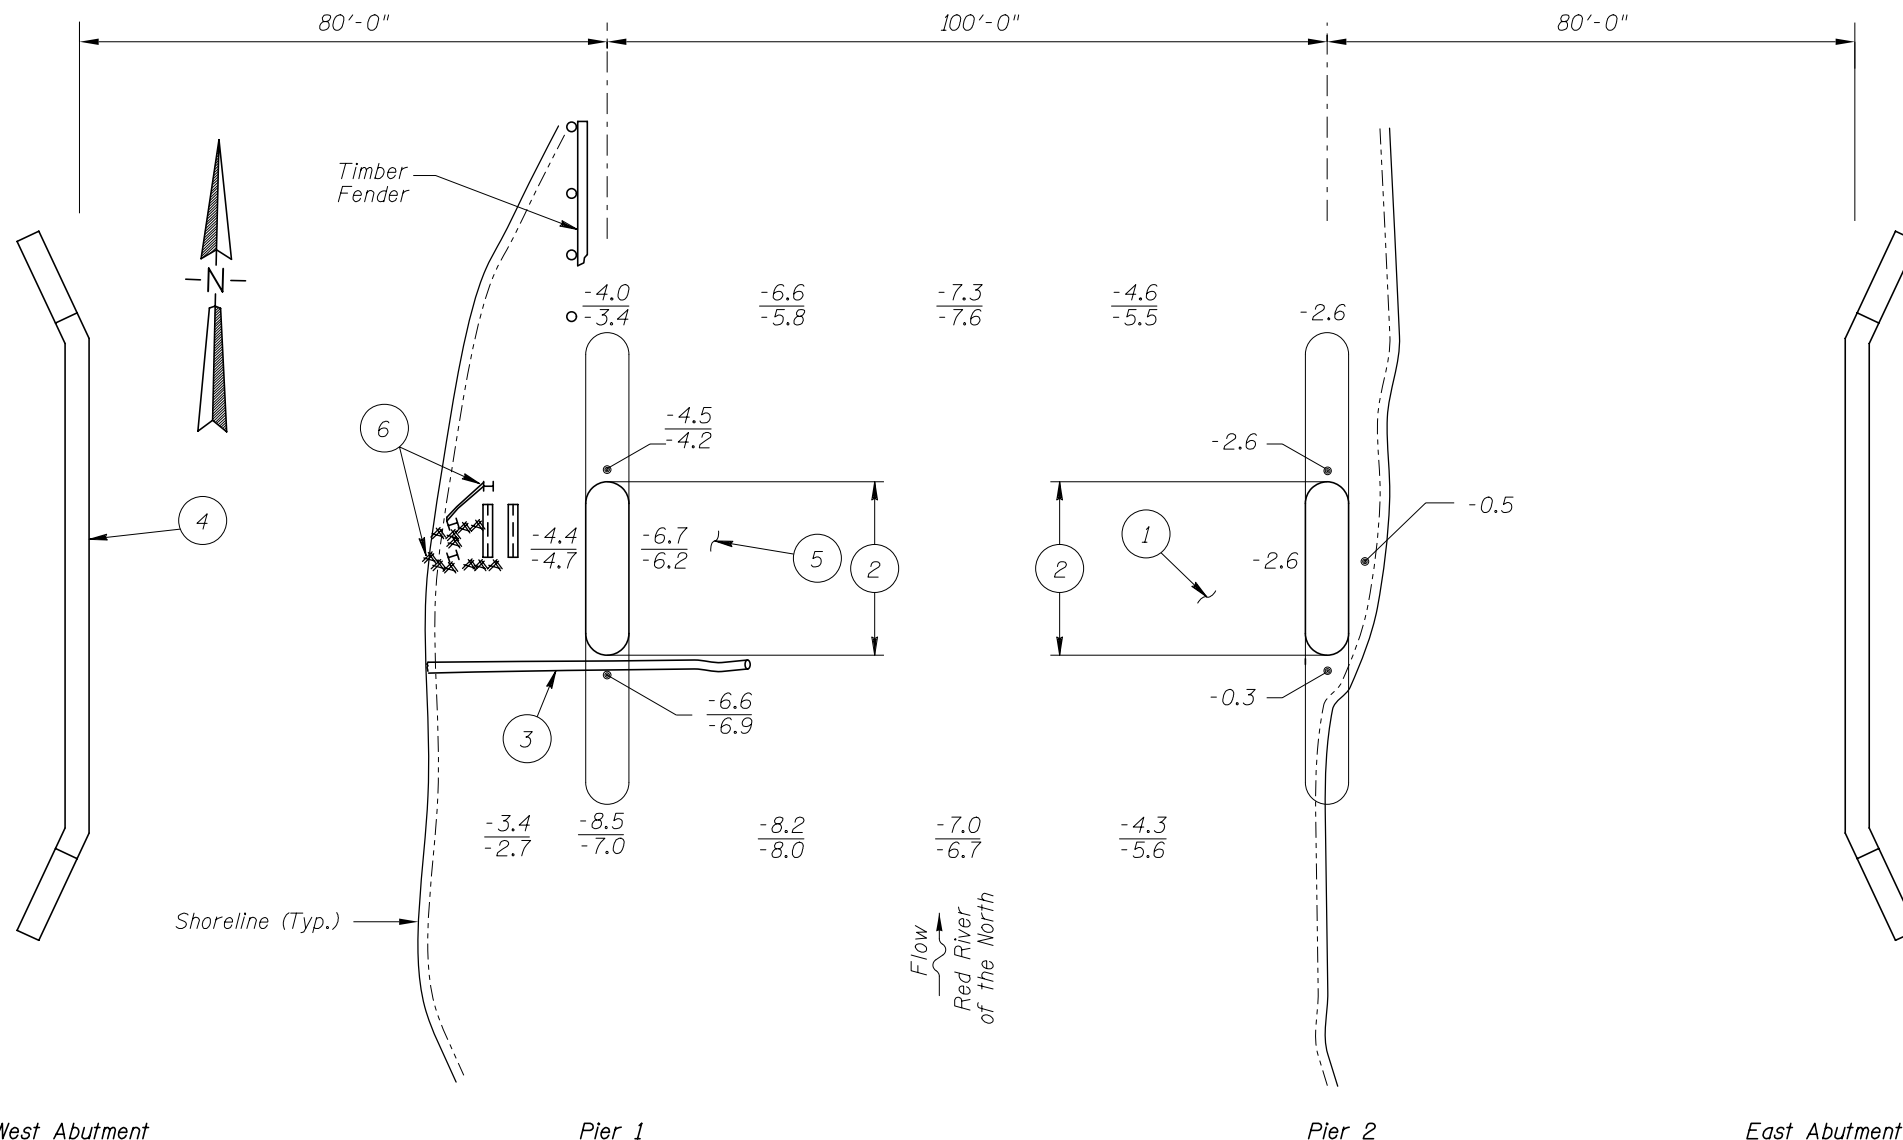
| MINNESOTA<br>DEPARTMENT OF TRANSPORTATION<br>UNDERWATER BRIDGE INSPECTION | | |
|---|--|---|
| Code: 52210055 | | Figure No.: 1 |

- (A) There was a 2 foot diameter log located along the upstream nose of Pier 1 extending from the West face to the West shoreline.
- (B) Erosion was observed at the embankment along the West Abutment which was beginning to undermine the pile cap.
- (C) Steel I-beams with scattered debris hung up within them were observed extending from the channel bottom to 7 feet above the waterline, along the West face of Pier 1 to the shoreline. There was also a 2-foot-diameter log across the upstream nose of Pier 1.

- (A) Monitor the timber debris, and if found to be increasing in the future, removal operations may become warranted.
- (B) Evaluate the bank erosion and assess the need to provide riprap along the West Abutment to prevent further erosion.
